# Debris/Ice/TPS Assessment And Integrated Photographic Analysis For Shuttle Mission STS-46

September 1992

DEBRIS/ICE/TPS ASSESSMENT  
AND  
PHOTOGRAPHIC ANALYSIS  
OF  
SHUTTLE MISSION STS-46

July 31, 1992

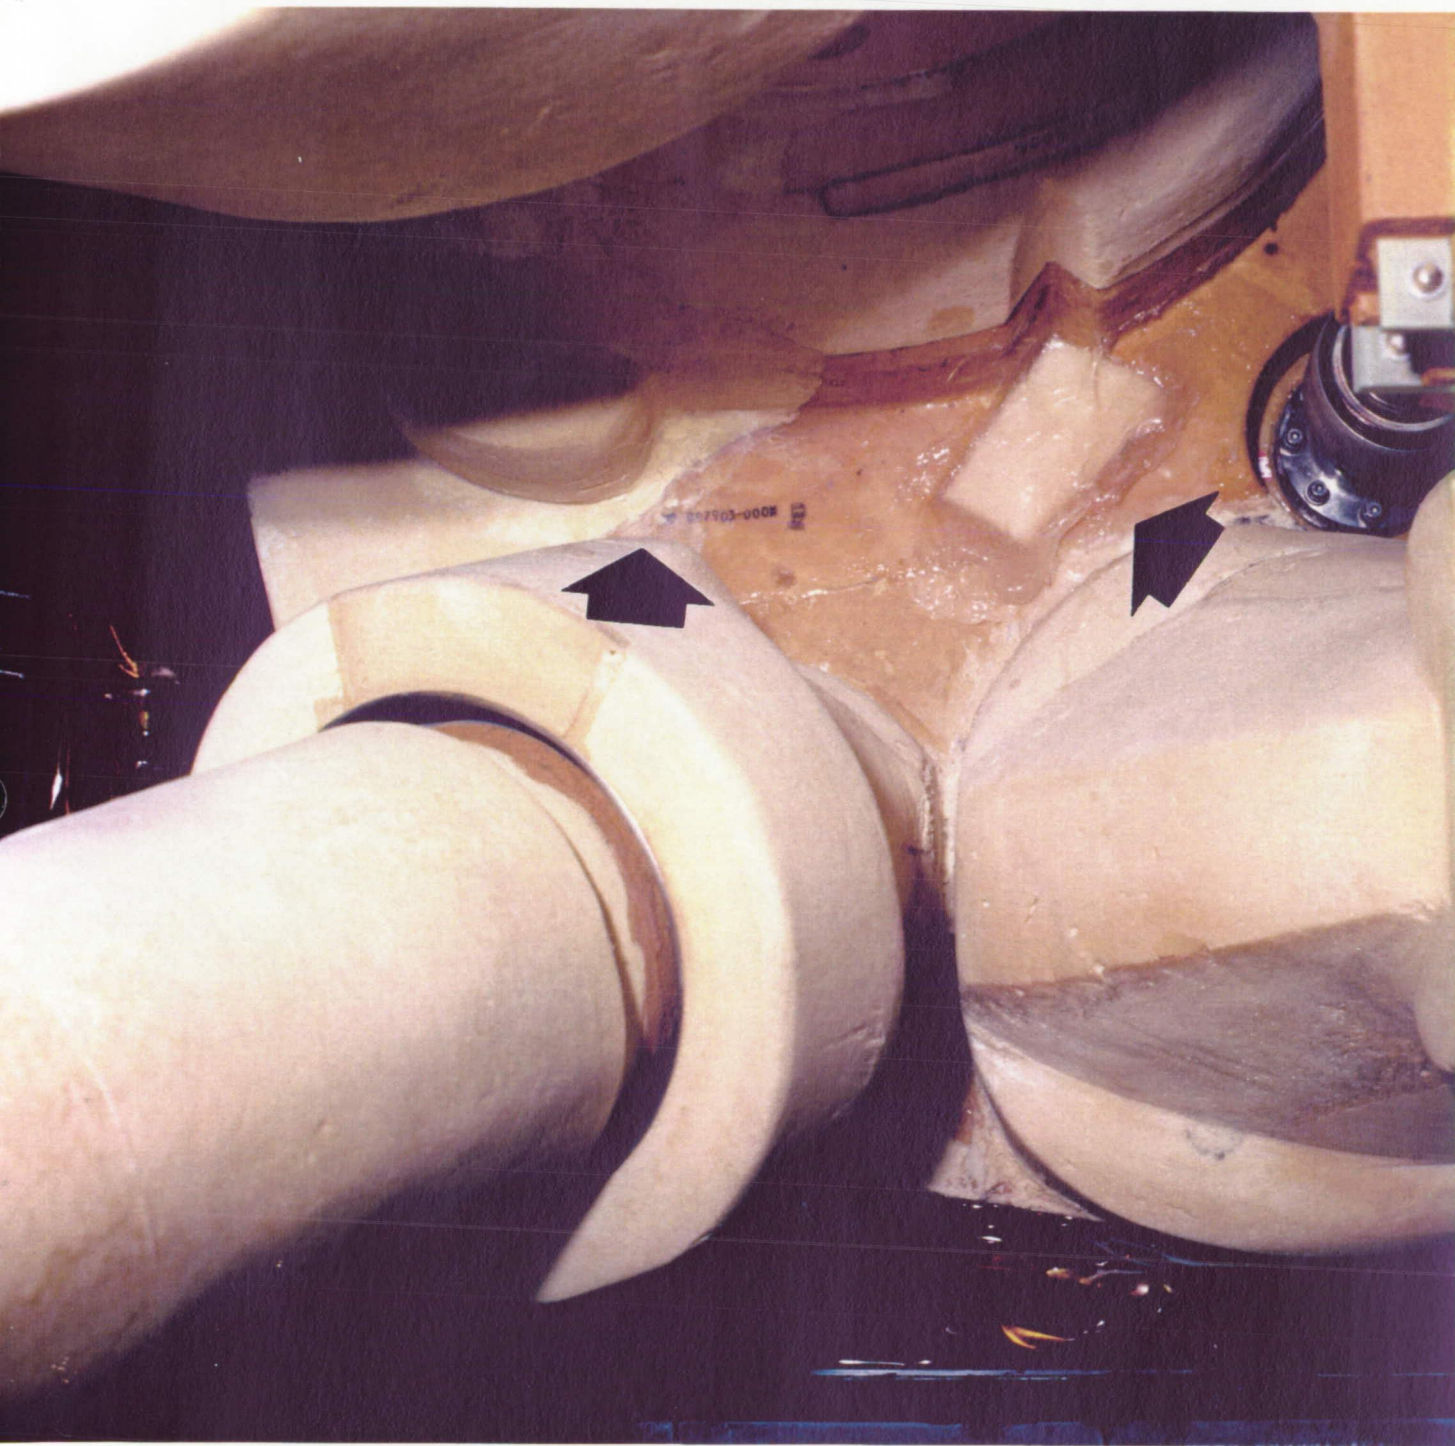
LH2 ET/ORB umbilical, including aft pyrotechnic canister closeout and 17-inch flapper valve actuator access port foam plug closeout, prior to cryogenic fuel loading.

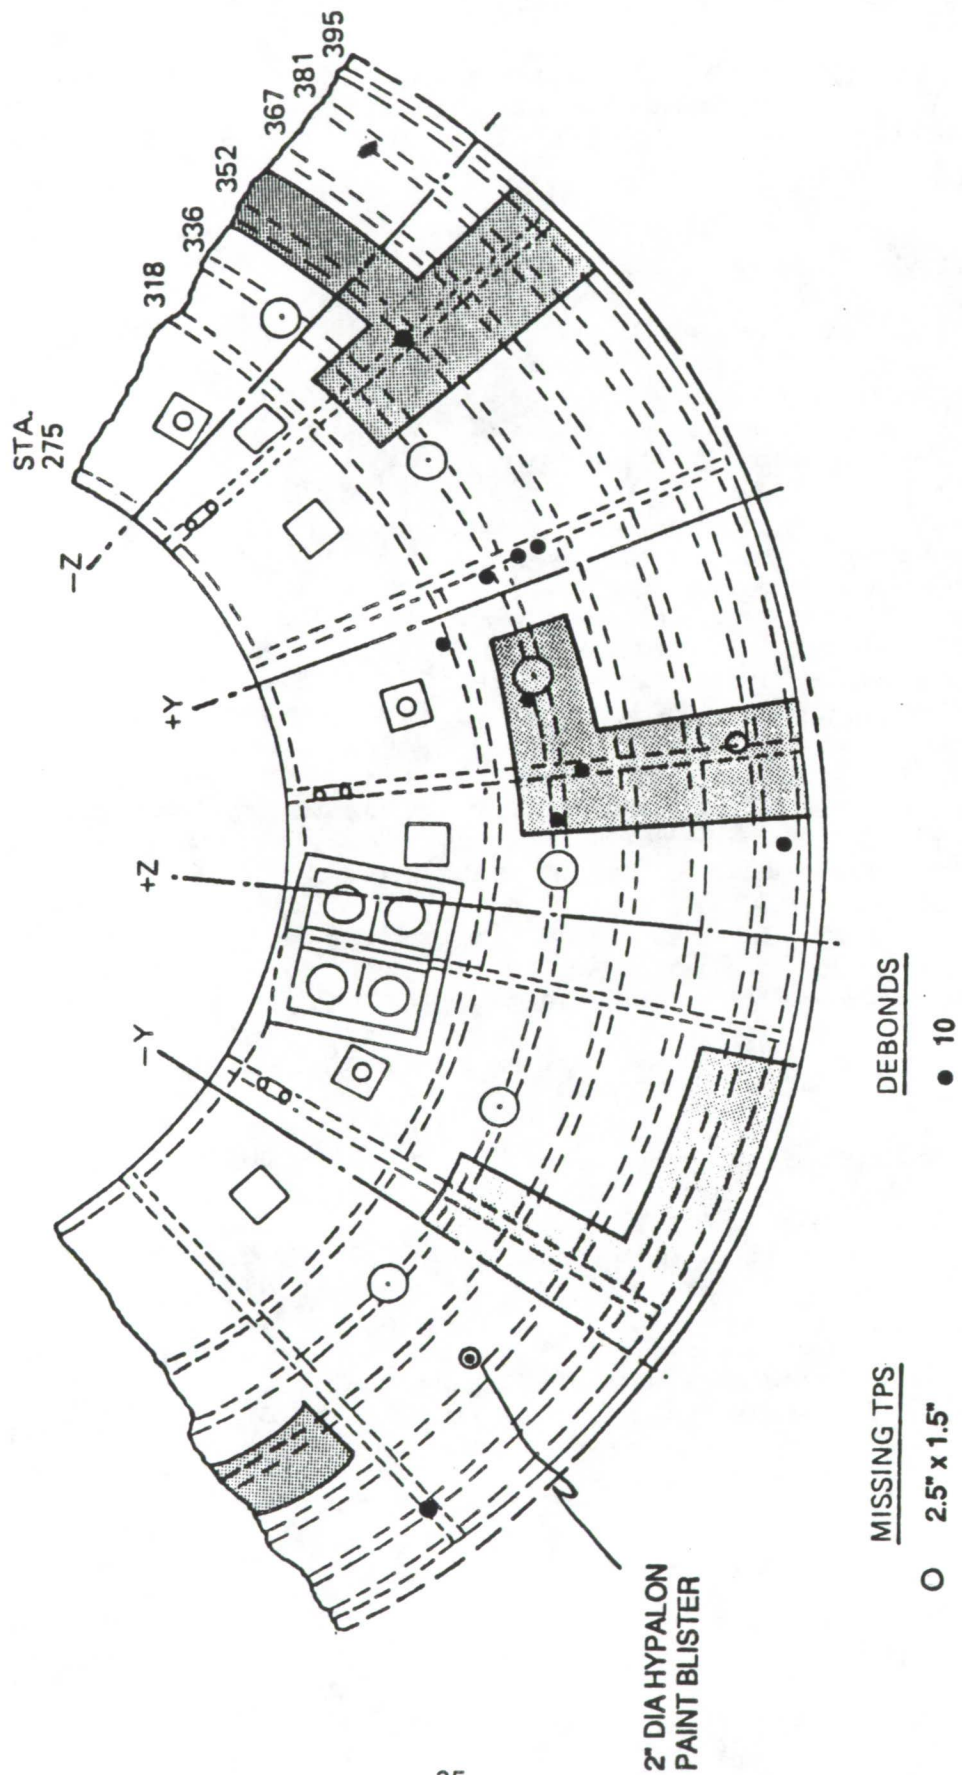
Figure 4. RIGHT SRB FRUSTUM

The RH frustum had 10 MSA-2 debonds over fasteners and one area of missing TPS, which measured 2.5"x1.5", near the 381 ring frame between the +Y and +Z axes (Figure 4). Minor localized blistering of the Hypalon paint had occurred in isolated areas. All BSM aero heatshield covers were locked in the fully opened position.

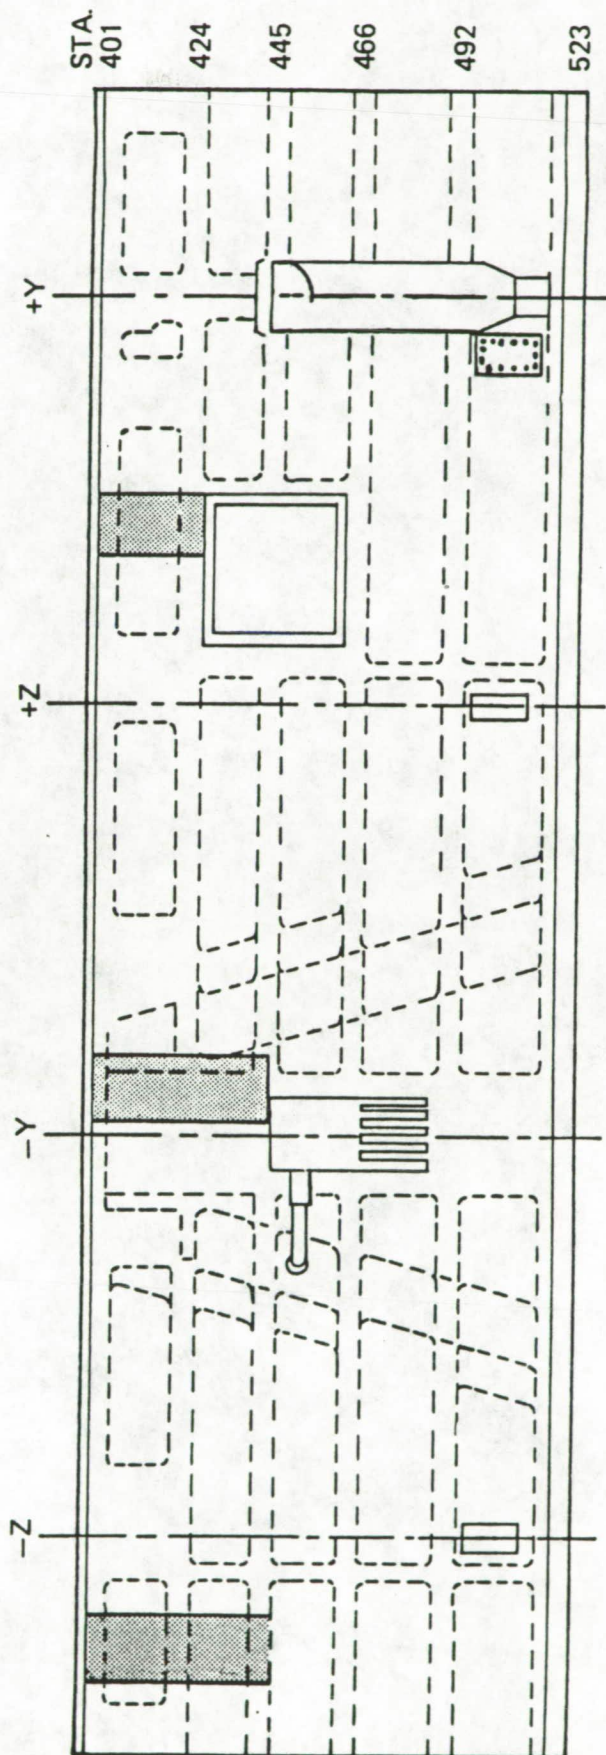
Figure 5. RIGHT SRB FWD SKIRT

The RH forward skirt exhibited no debonds or missing TPS. Both RSS antennae were intact and undamaged. Minor blistering of the Hypalon paint occurred on the systems tunnel cover and forward ET/SRB attach point (Figure 5). No pins were missing from the frustum severance ring. The forward separation bolt and electrical cables appeared to have separated cleanly.

TPS MISSING  
NONE

DEBONDS  
NONE

MINOR BLISTERING OF  
HYPALON PAINT ON  
SYSTEMS TUNNEL COVER  
AND ET/SRB ATTACH POINT

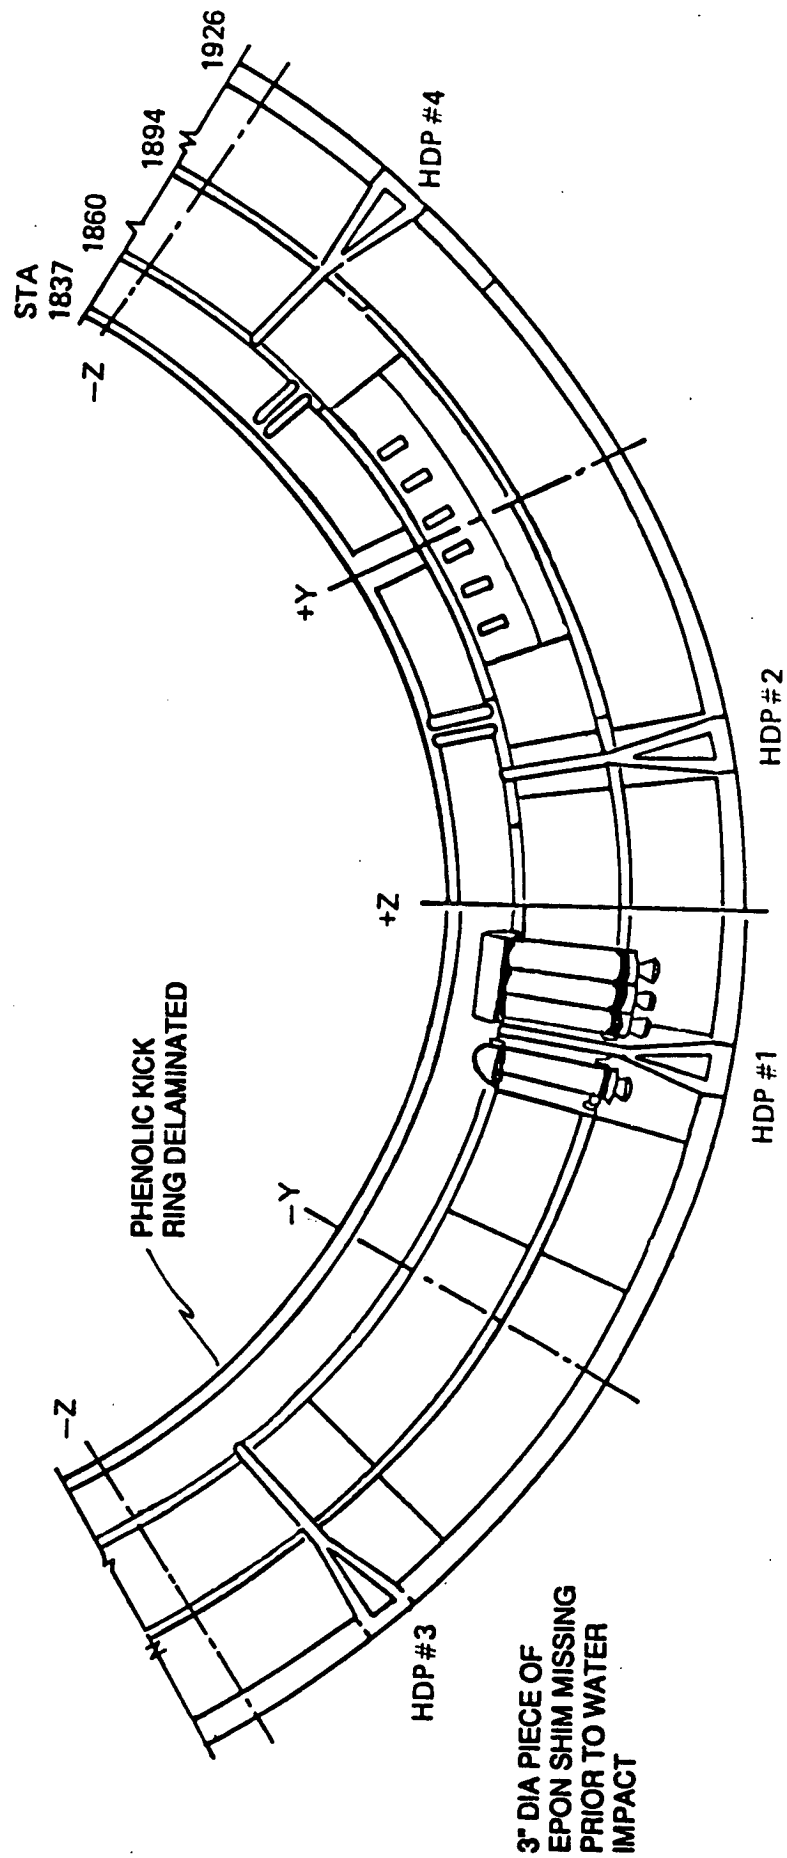
Figure 6. RIGHT SRB AFT SKIRT EXTERIOR TPS

The phenolic material on the kick ring had delaminated. The K5NA closeouts (protective domes) on the kick ring forward and aft fasteners had been eliminated. RTV-133 replaced the K5NA over the forward fasteners. The aft fasteners were uncovered. The aft skirt acreage TPS was in good condition (Figure 6).

All four Debris Containment System (DCS) plungers were properly seated. This was the ninth flight utilizing the optimized link. A 3-inch diameter piece of the HDP #3 EPON shim was missing prior to water impact (sooted/charred substrate).

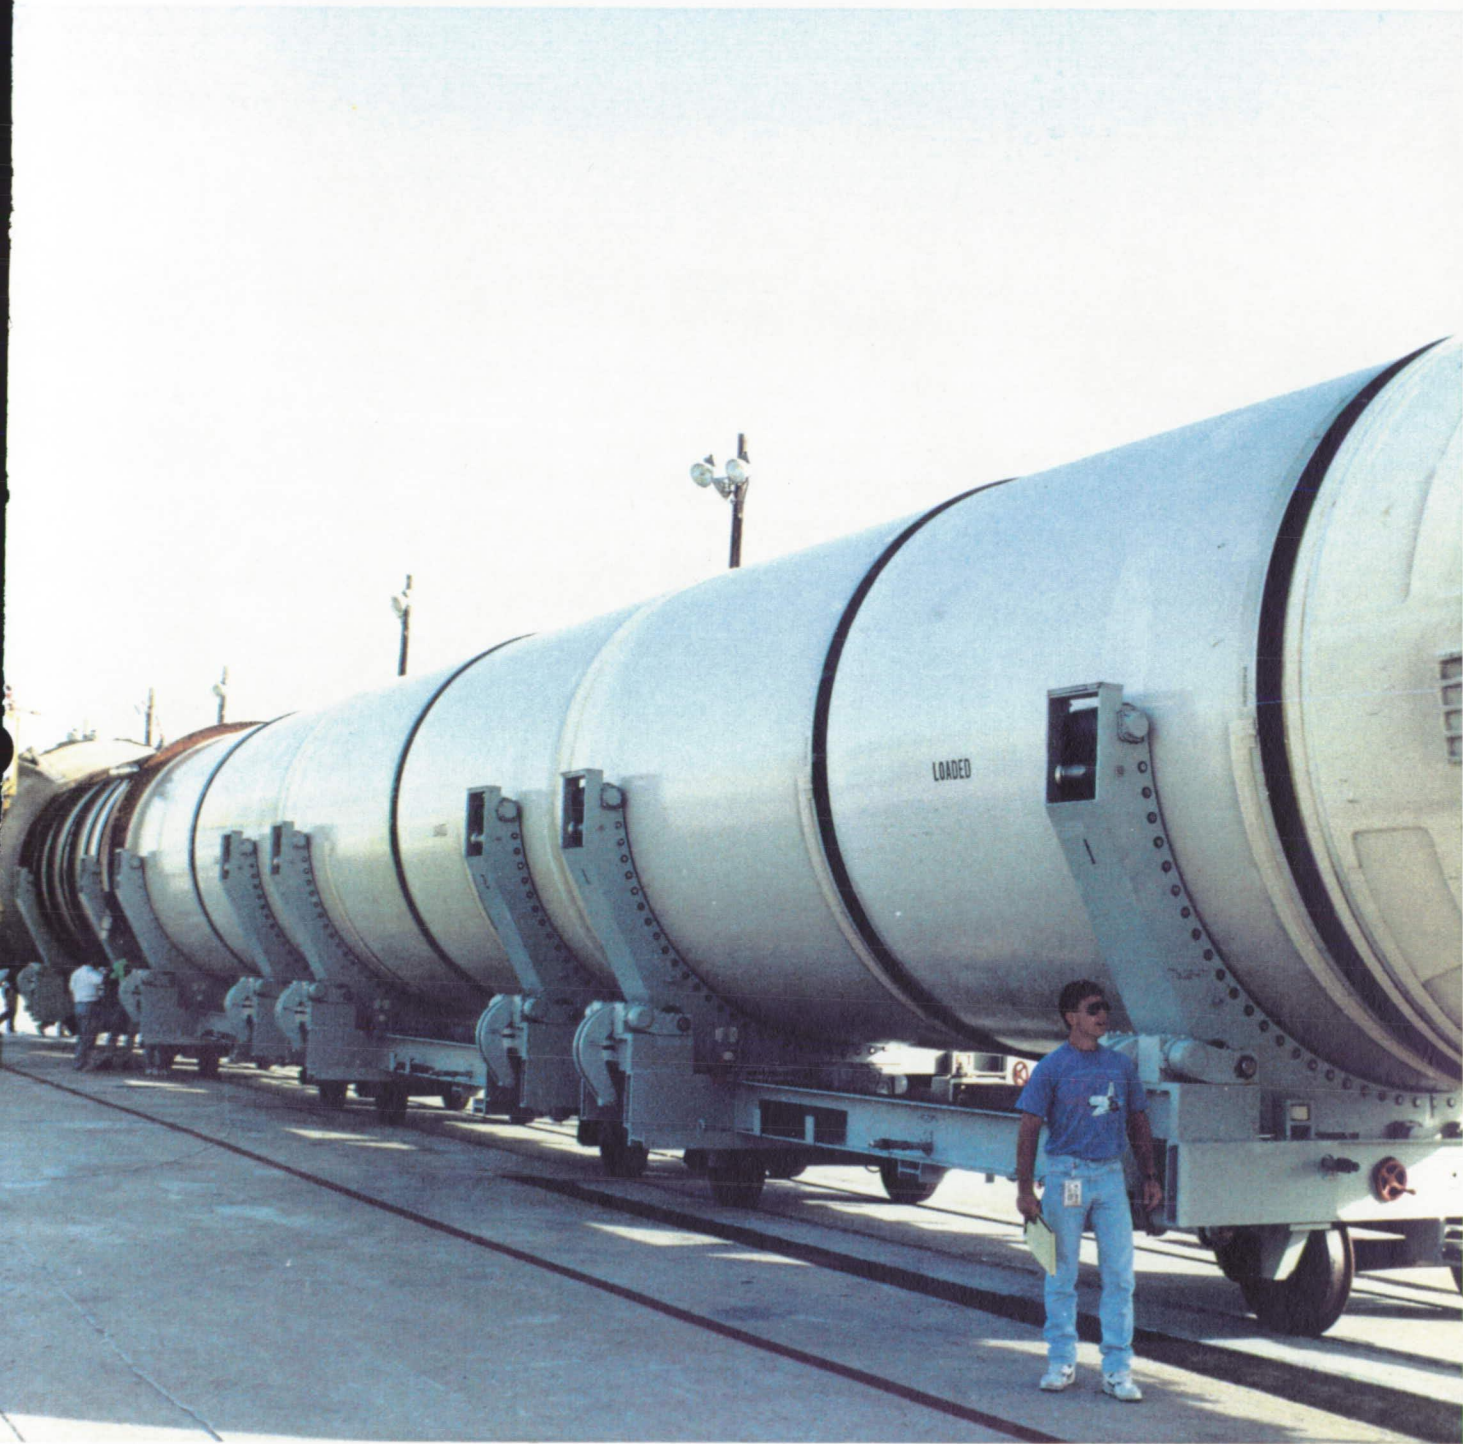
Post flight condition of the SRM segment cases, factory joints,  
and field joint closeouts

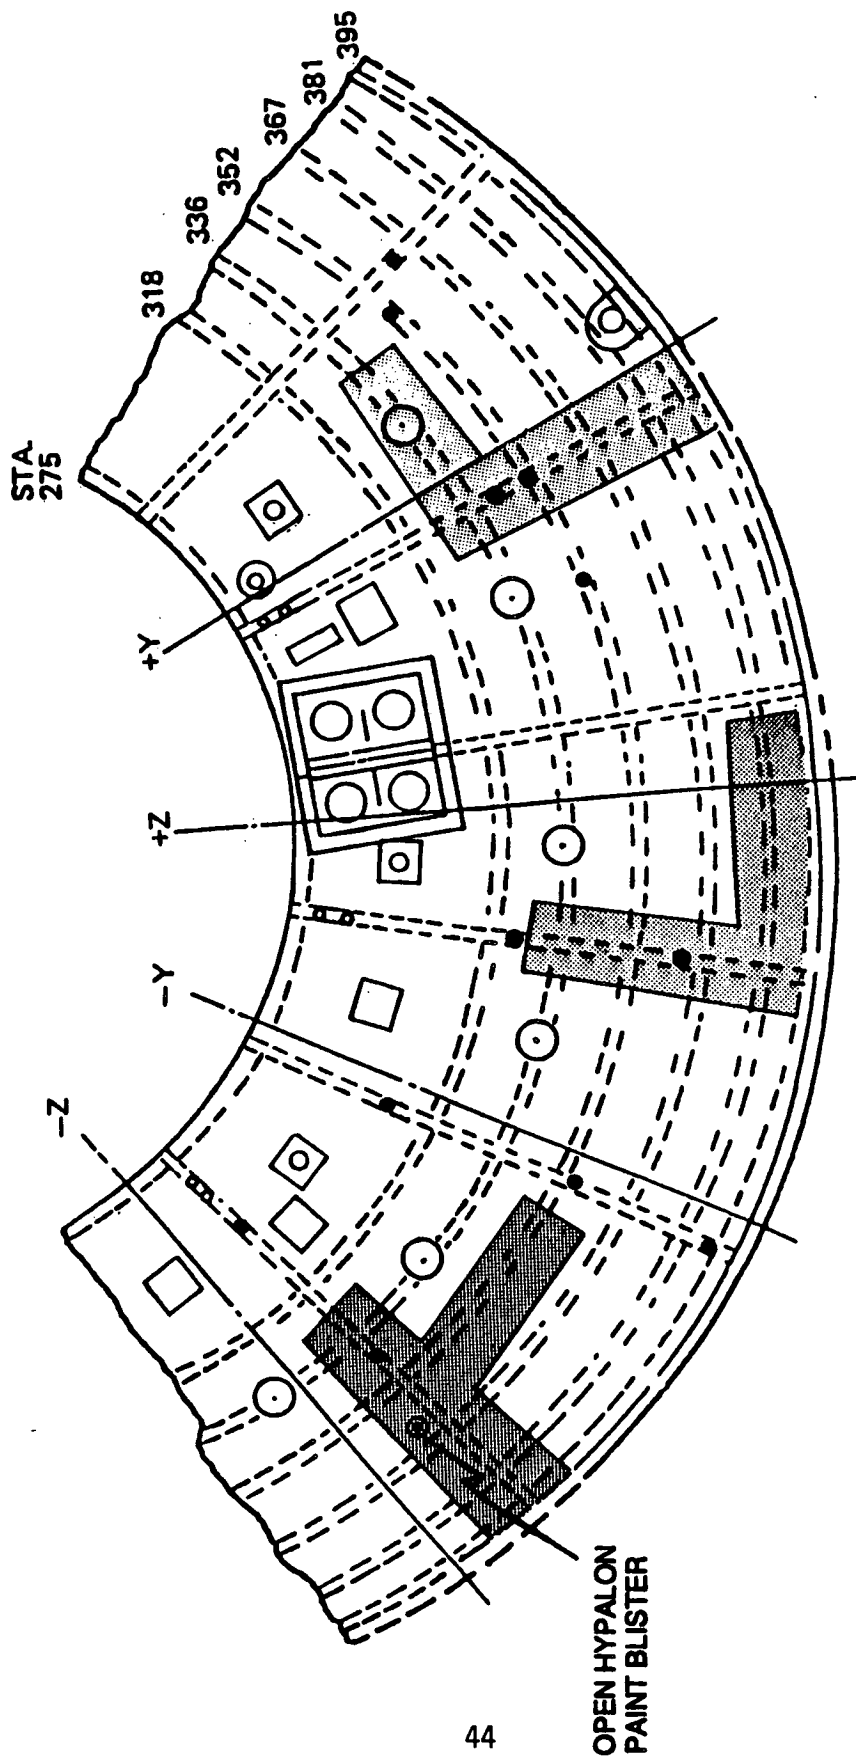
Figure 7. LEFT SRB FRUSTUM

The LH frustum was missing no TPS but had 12 MSA-2 debonds over fasteners. There was very minor localized blistering of the Hypalon paint in isolated areas. The BSM aero heatshield covers were locked in the fully opened position (Figure 7).

MISSING TPS

NONE

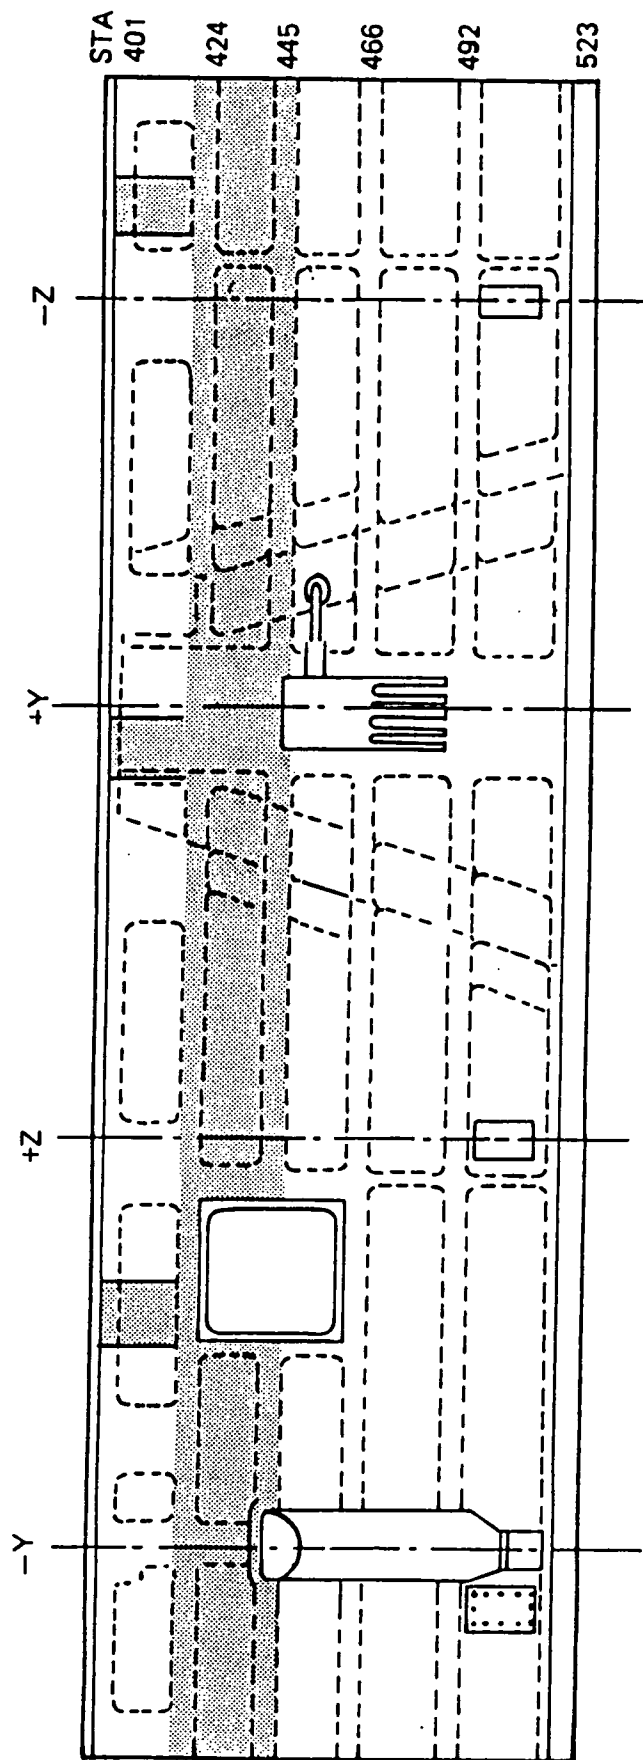
Figure 8. LEFT SRB FWD SKIRT

The LH forward skirt exhibited no debonds or missing TPS. The phenolic plates on both RSS antennae were intact. The forward separation bolt and electrical cables appeared to have separated cleanly. No pins were missing from the frustum severance ring. Minor blistering of the Hypalon paint occurred around the ET/SRB attach point (Figure 8).

TPS MISSING

NONE

MINOR BLISTERING OF  
HYPALON PAINT ON  
ET/SRB ATTACH FITTING

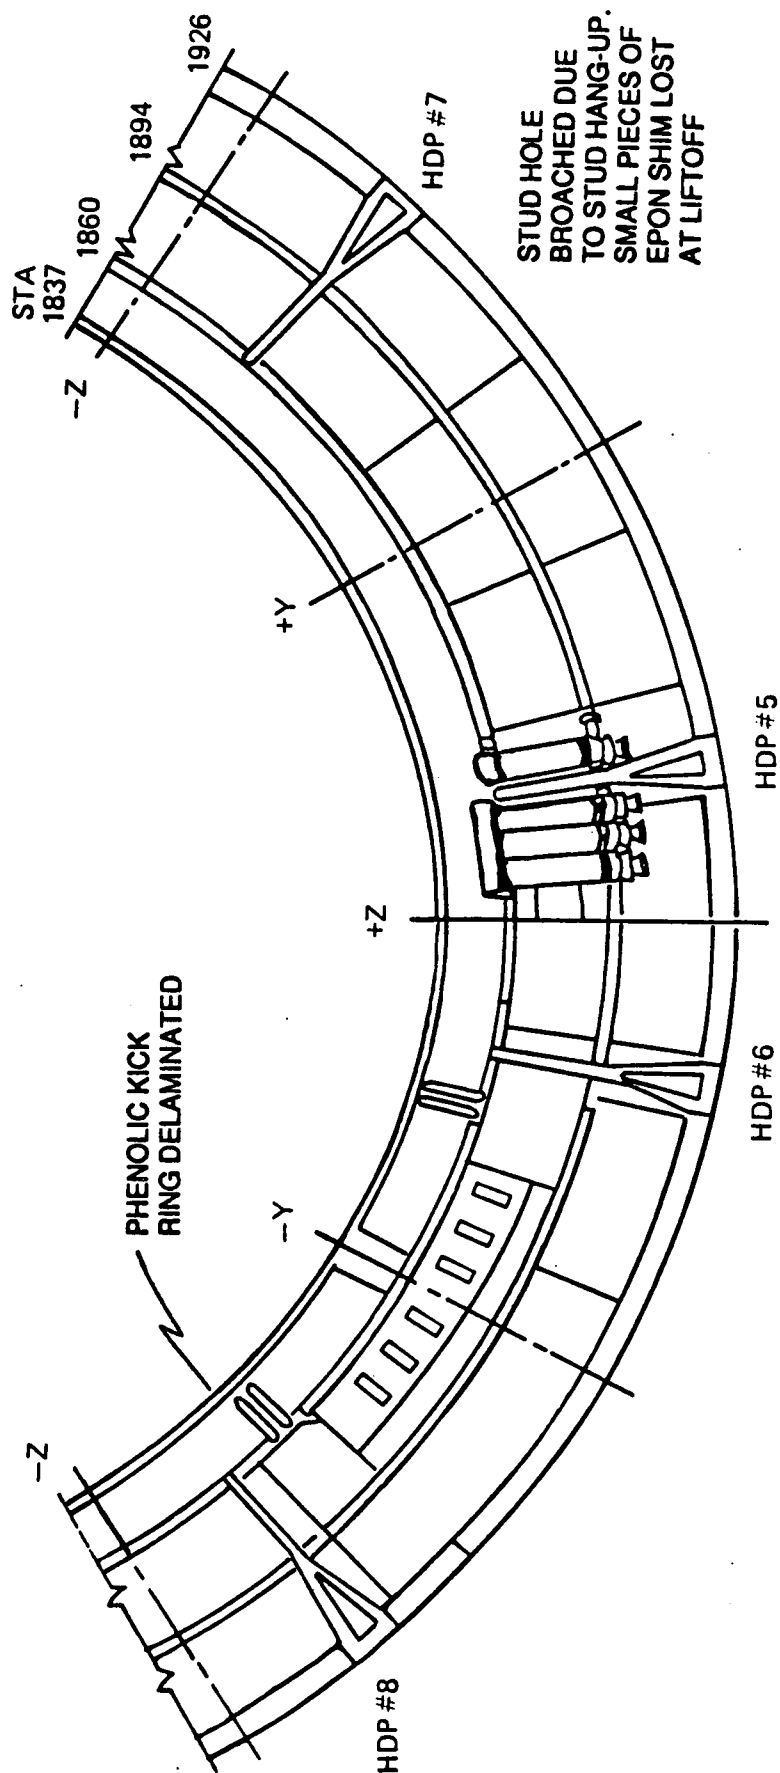
Figure 9. LEFT SRB AFT SKIRT EXTERIOR TPS

The phenolic material on the kick ring had delaminated. The K5NA closeouts (protective domes) on the forward and aft fasteners on the kick ring had been eliminated (Figure 9). RTV-133 replaced the K5NA over the forward fasteners. The aft fasteners were uncovered. The aft skirt acreage TPS was in good condition.

The HDP #7 stud hole was broached due to a stud hang-up at lift off as observed in the launch films. Small pieces of the EPON shim material adjacent to the stud hole had been pulled off by the stud. All four Debris Containment System (DCS) plungers were properly seated. This was the ninth flight utilizing the optimized link. None of the remaining EPON shim material was lost prior to water impact.

ALL DCS PLUNGERS  
SEATED PROPERLY

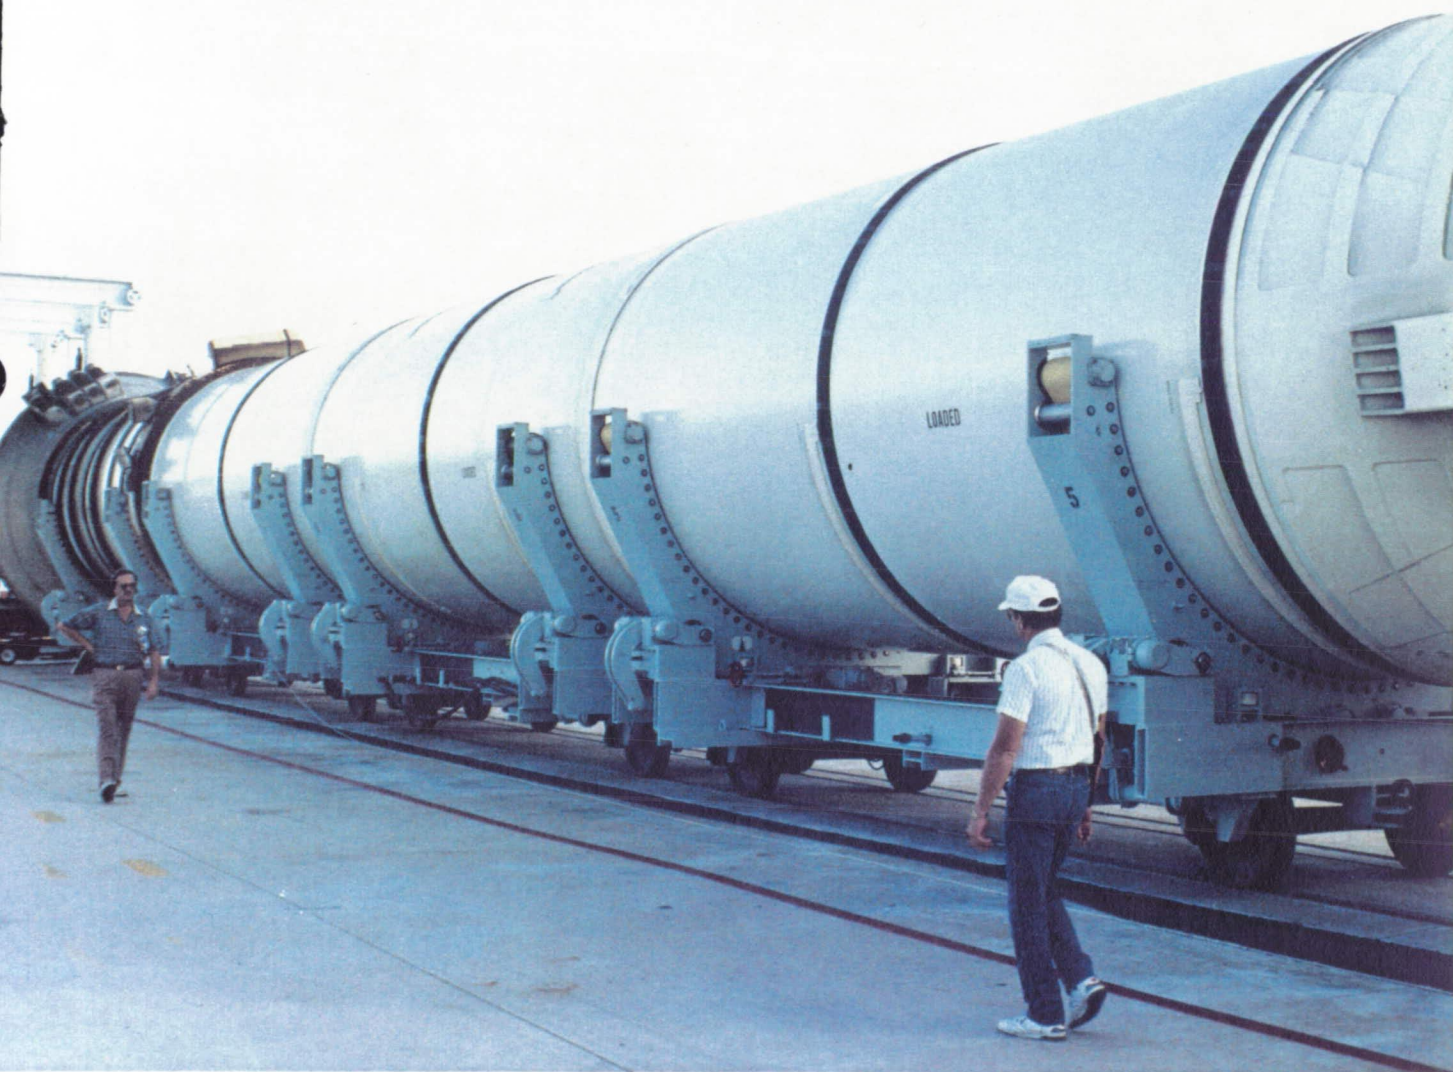
Post flight condition of the SRM segment cases, factory joints,  
and field joint closeouts

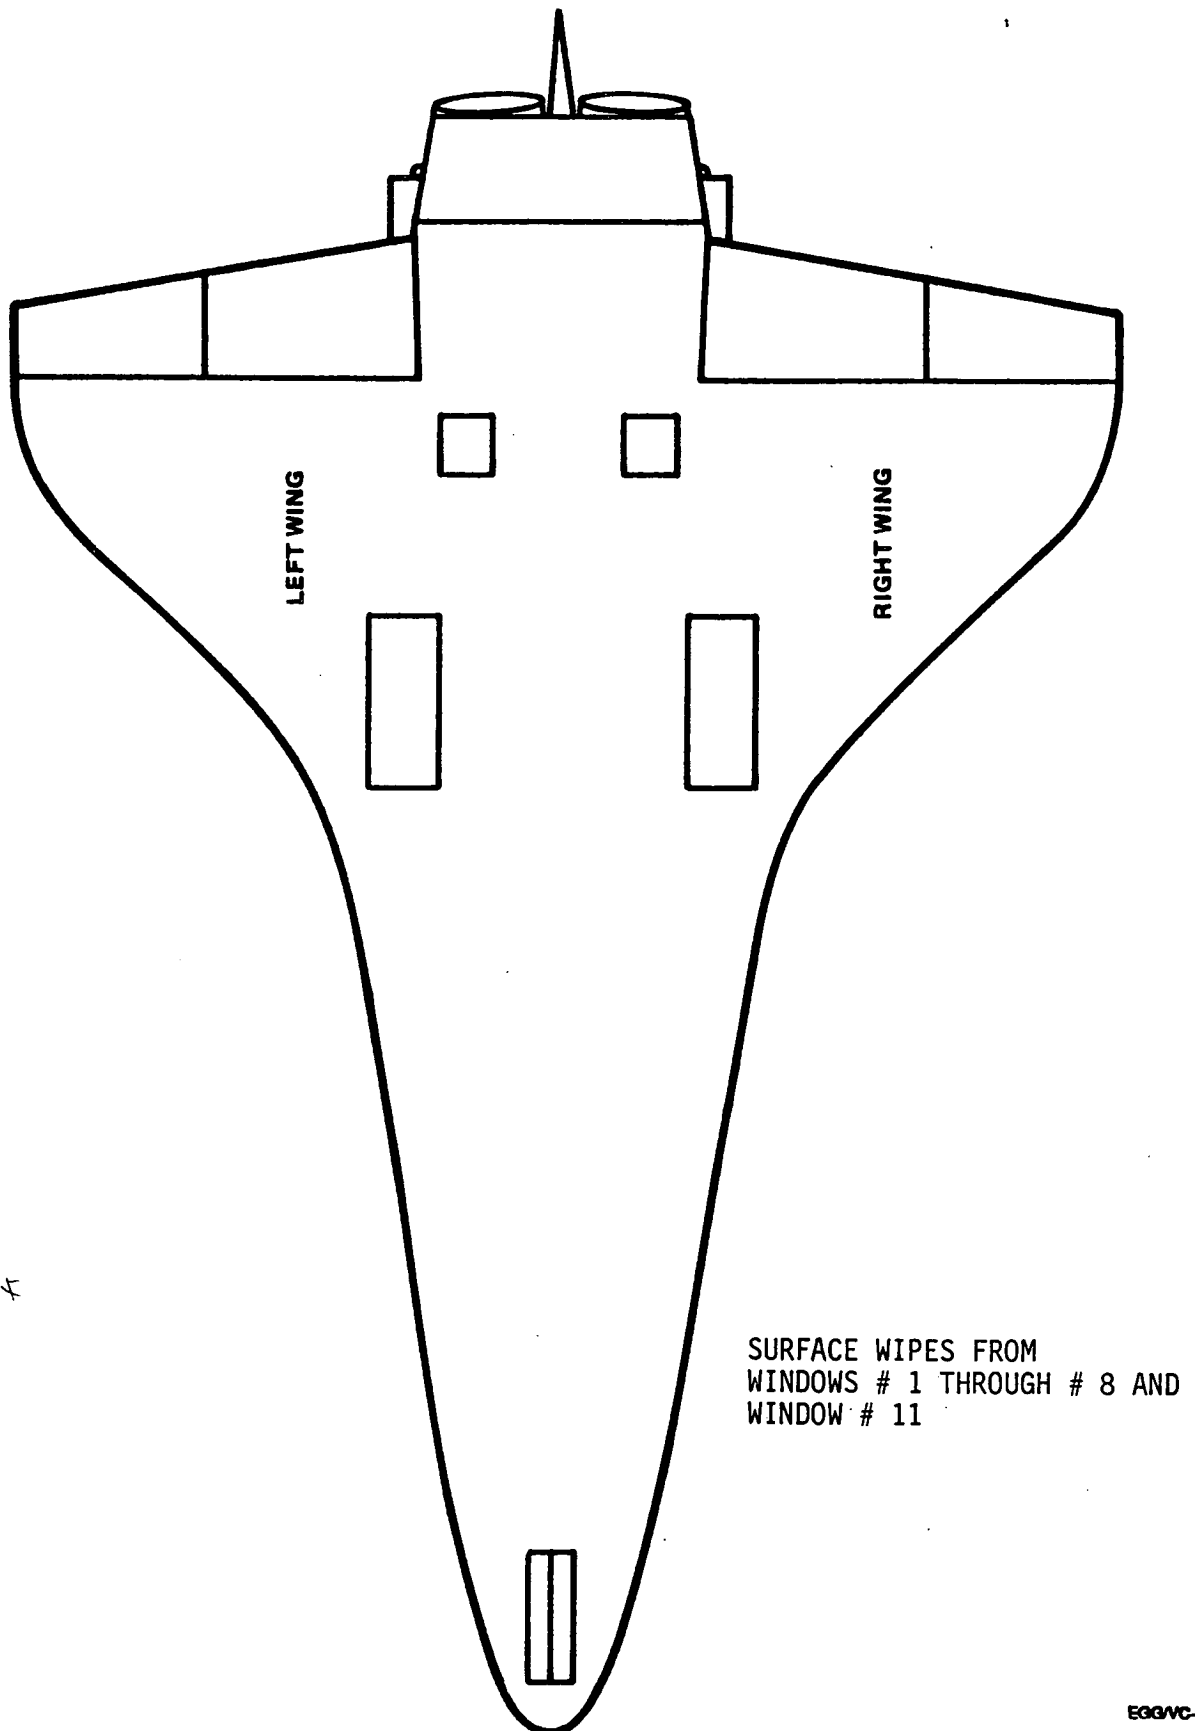
Figure 14. **CHEMICAL SAMPLE LOCATIONS**

Orbiter windows #3 and #4 exhibited moderate hazing with a few streaks. Hazing on the other windows was less than usual. Laboratory analysis will be performed on samples taken from the windows (reference Figure 14). Six damage sites were noted on the perimeter tiles around window #3. The impact sites were only surface coating losses or were no more than 1/4 inch deep. This damage may have been caused by the RTV used to bond paper covers to the FRCS nozzles or by exhaust products from the SRB booster separation motors.

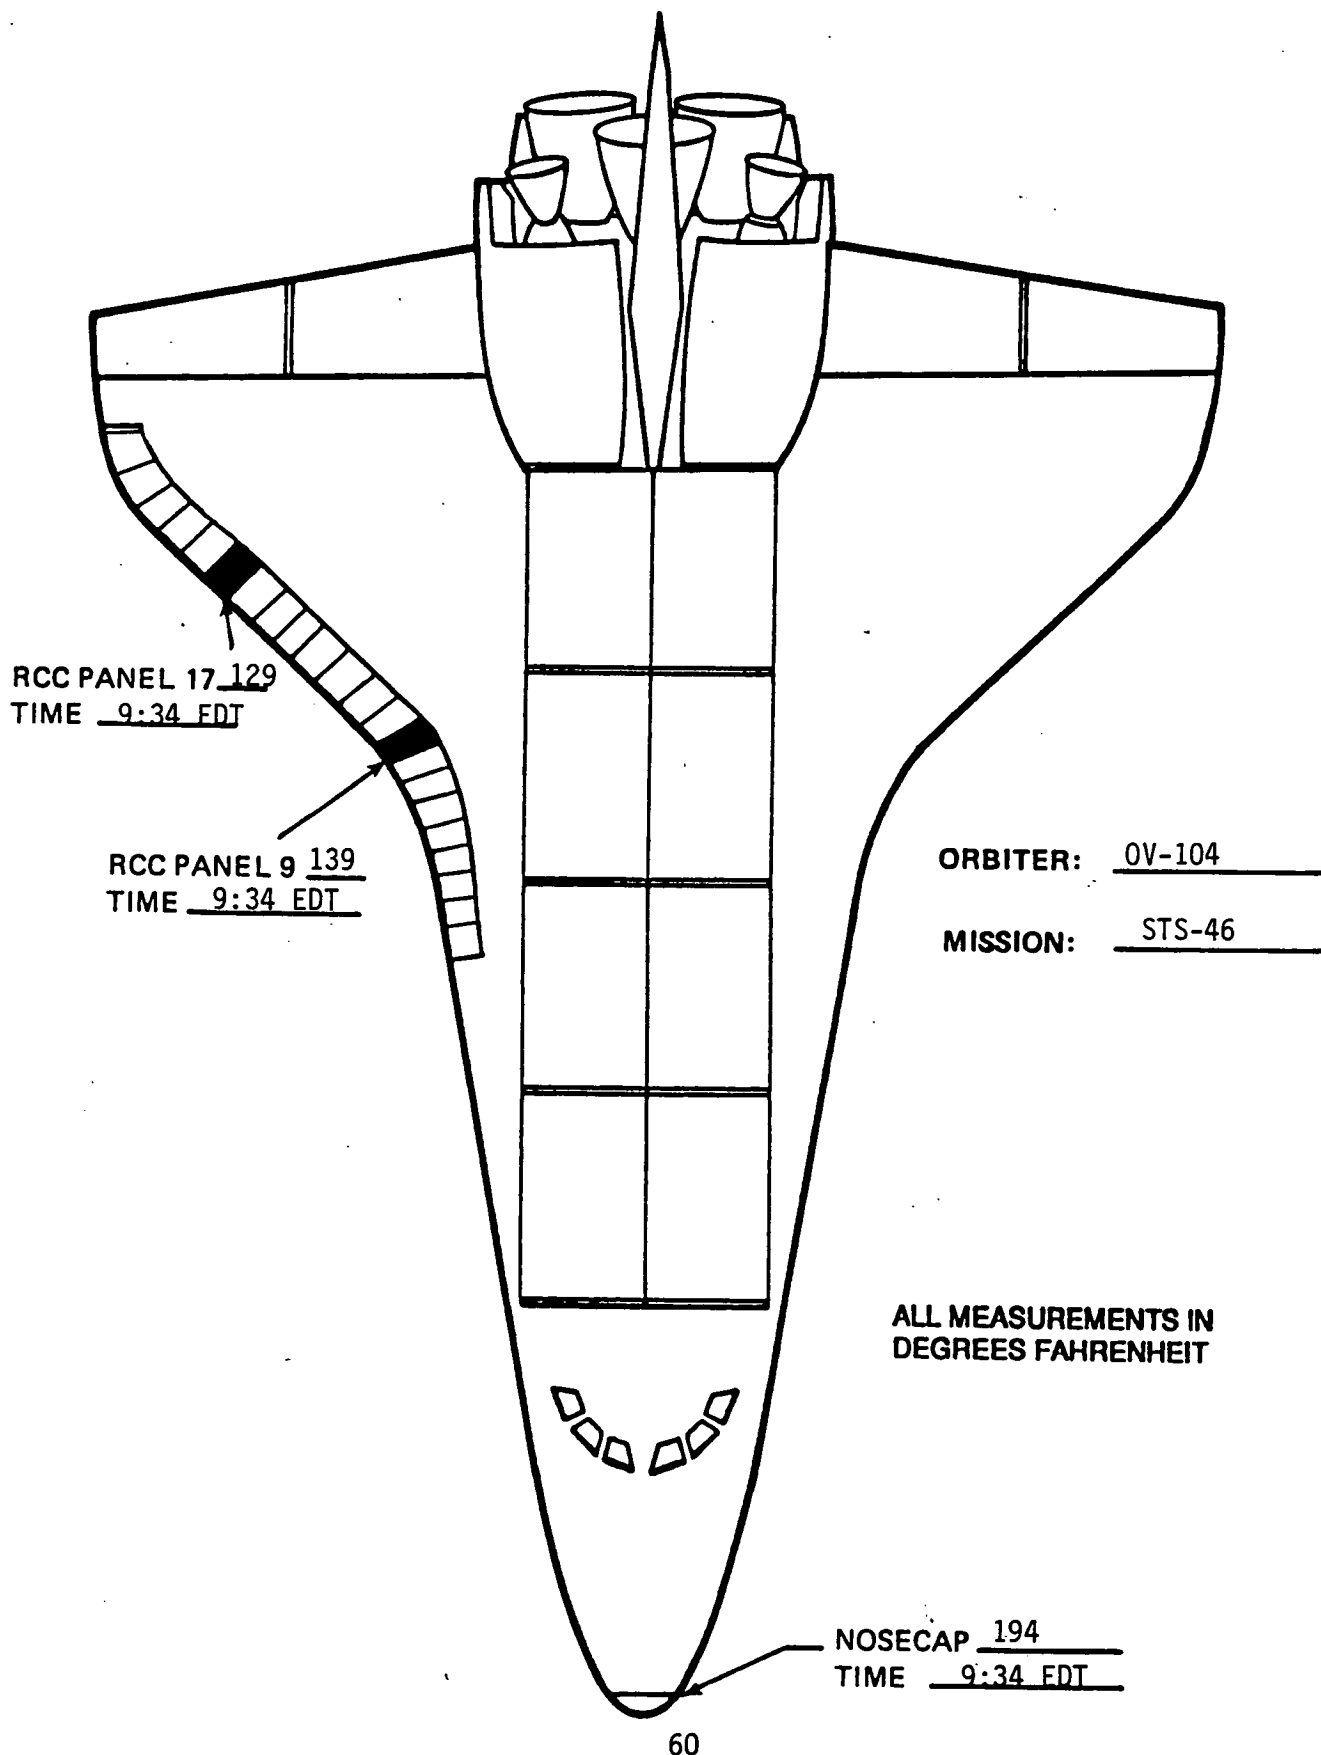
Figure 15. **STS-46 RCC TEMPERATURE MEASUREMENTS AS  
RECORDED BY THE SHUTTLE THERMAL IMAGER**

A portable Shuttle Thermal Imager (STI) was used to measure the surface temperatures of three areas on the Orbiter TPS after landing (per OMRSD V09AJ0.095). Twenty-two minutes after landing the Orbiter nose cap RCC was 194 degrees F, the RH wing leading edge RCC panel #9 was 139 degrees F, and panel #17 was 129 degrees F (reference Figure 15).

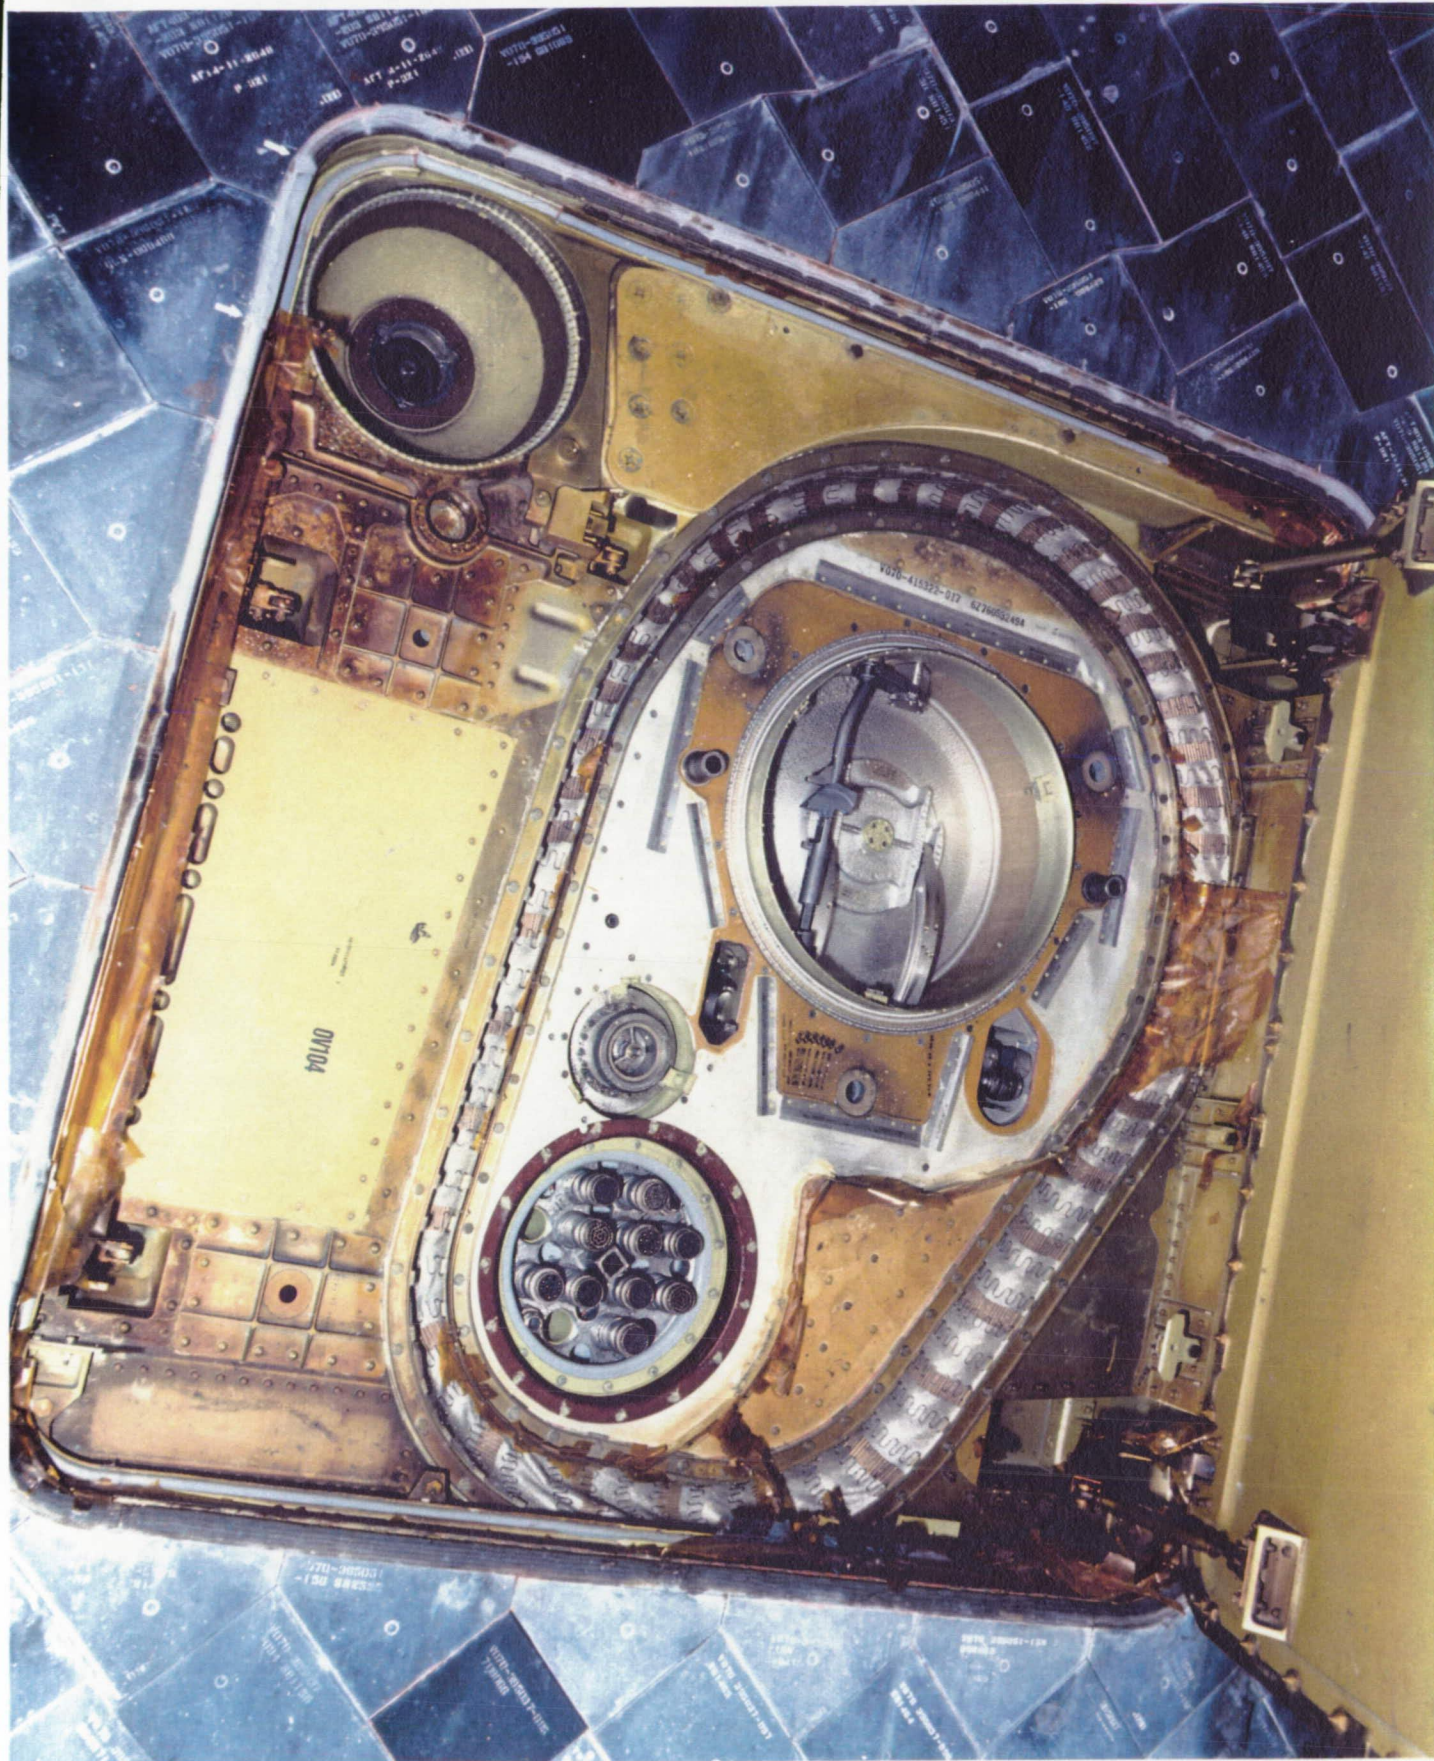
Overall view of the LO2 ET/ORB umbilical. All separation ordnance devices appeared to have functioned properly. No flight hardware was found on the runway below the umbilical when the ET door was opened.
